# Failure Investigations of Failed Micro Spline Plug Stem of SS 420 Used in Control Valve

## ABSTRACT

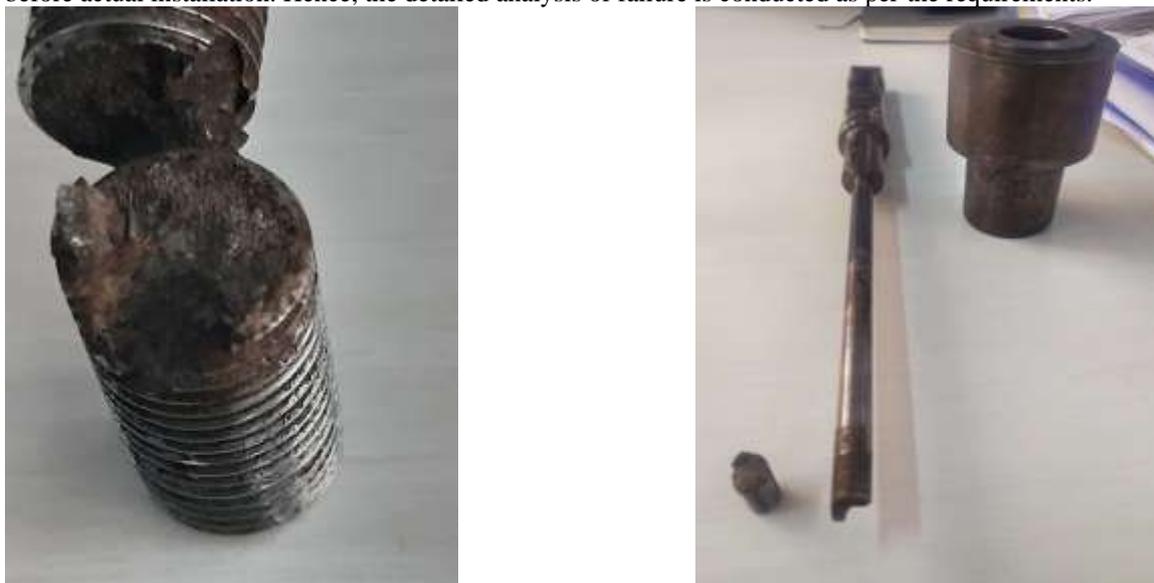
ASTM A275 Type SS 420 plug component identified as a valve plug stem, which was broken while in service. The details site images of crack generation and failure is as shown in Fig. 1. It was required to study the nature and likely cause of failure. With reference to the problem of broken plug stem, the issue was reported on 26 May 2020, after reviewing the damaged part, material for plug stem is identified as (SS420). This plug (JP12682) is manufactured in house as per requirement of the project. In same project 5 valves are similar, but 4 plugs machined out sourcing. Plug stem broken from top side threads which is weakest portion & its observed slightly bend condition & its run out shows 0.15 to 0.17 mm.

FIGURE 1. Failure of plug stem.

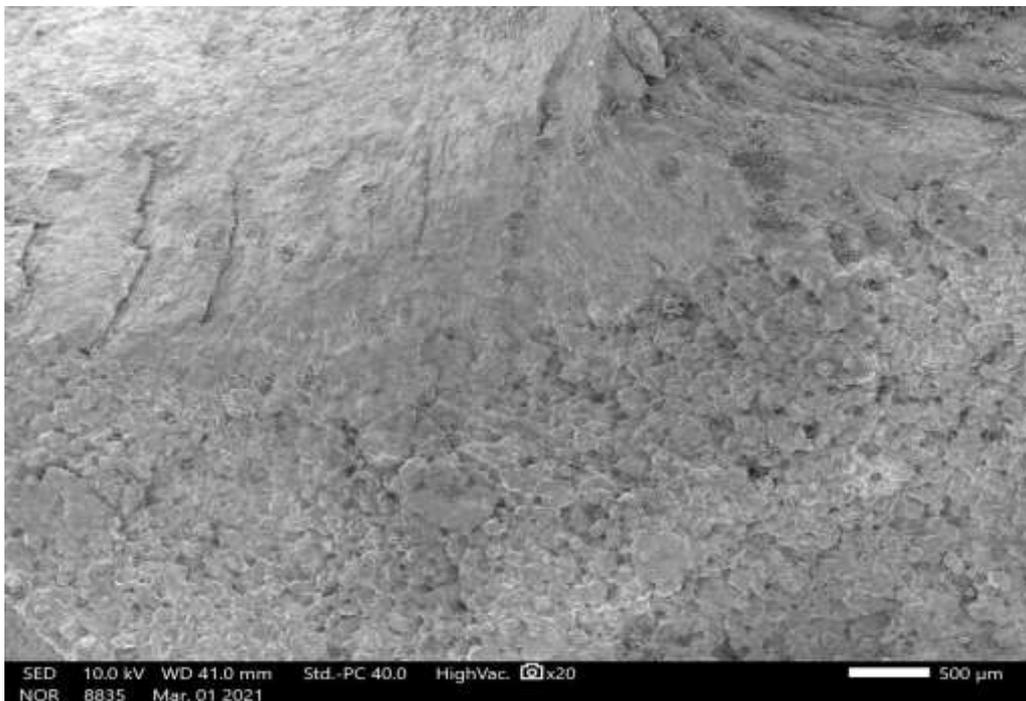
FIGURE 6. SEM image of failed crosssection showing intergranular carbides

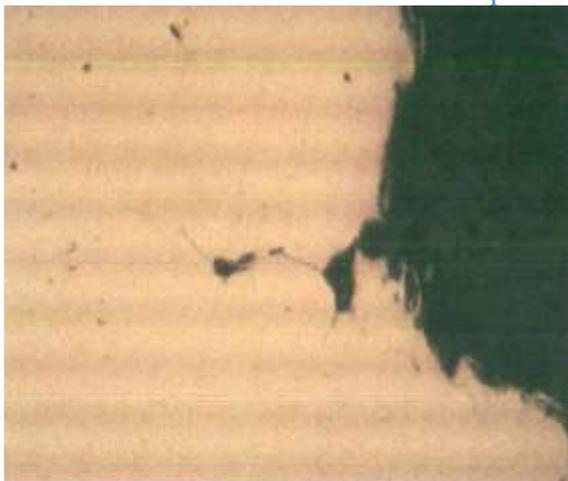
A metallurgical cross section was removed from the vicinity of the crack and a metallographic sample was first mechanically wet ground using a 1500 grit silicon carbide (SiC) paper, then polished with aluminium oxide (Al<sub>2</sub>O<sub>3</sub>) powder of 3 and 0.25 mm diameter, followed by electro etching according to ASTM E 407. After etching, the specimen was cleaned with distilled water and methanol, and then dried in air. The Fig. 2 and Fig. 3, shows the crack morphology using optical microscopy. The no etched portion clearly shows the cracks along the grain boundary and etched portion shows tempered martensite along the grains. It was observed that the surface microstructure of the plug had a tempered martensitic structure and the metallography of the cracked sample revealed highly distributed grain boundary carbides, which are both intergranular, and transgranular. Fig. 2 and Fig. 3 shows the optical micrographs showing propagation the crack along the grain boundaries

FIGURE 2. Optical micrographs showing propagation the crack along the grain boundaries.

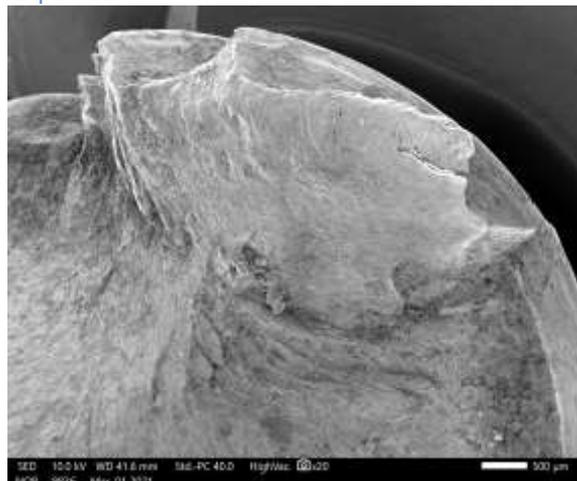
FIGURE 4. SEM image failed surface morphology showing fracture surface

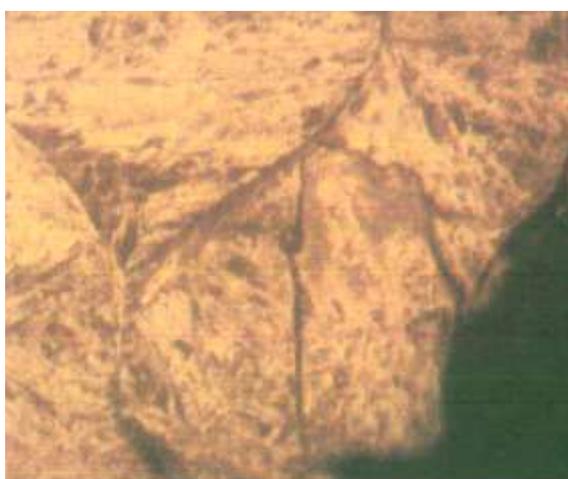
FIGURE 3. Optical micrographs showing martensitic SS 420 with intergranular cracks and grain droppings near the crack tip of the boundaries

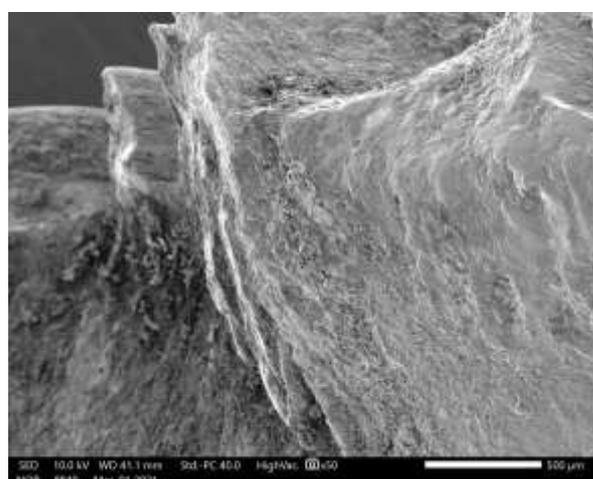
FIGURE 5. SEM image failed surface morphology showing brittle fracture surface

influenced the appearance of intergranular facets during fatigue crack growth. From the various microstructures introduced, materials with martensitic structure and grain boundary embrittlement showed intergranular facets. The appearance of intergranular facets as seen in SEM images, the fatigue fractures in martensitic structure and in 535~ tempered structure can be attributed to ease in fracture along grain boundaries due to dislocation pile ups at grain boundaries and impurity segregations weakening the grain boundaries. The scanning electron micrograph in Fig. 4-5 represents the typical striation morphology of the hardened and tempered structures showed a transgranular mode of crack propagation, striation formation and ductile tearing. It has been concluded that grain-boundary segregations and carbide precipitation, intergranular network of delta ferrite at prior austenitic grain boundaries may leads to this type of failure.

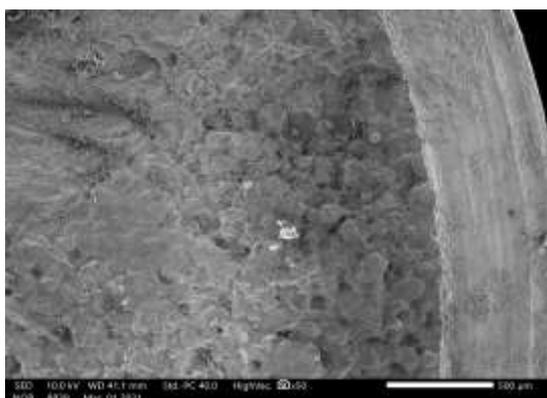
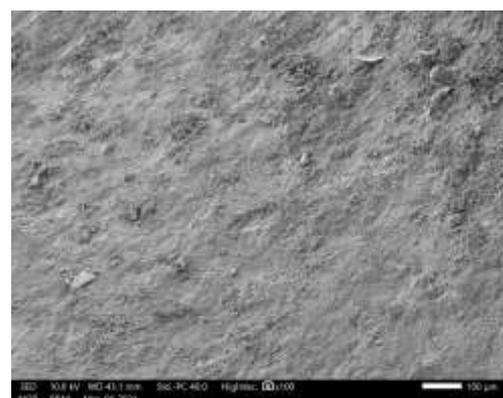
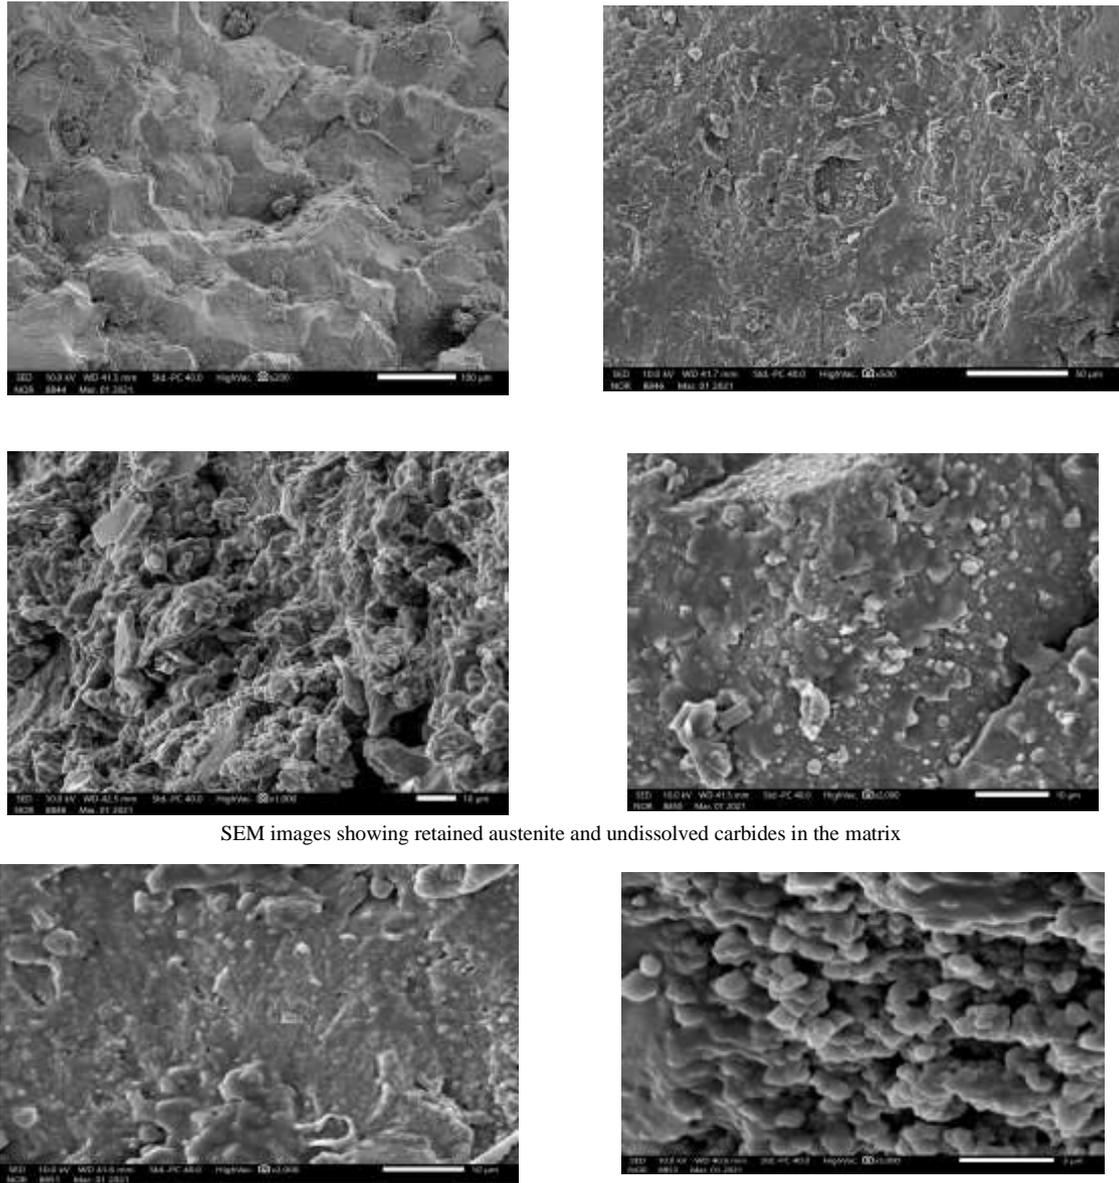
SEM images showing retained austenite and undissolved carbides in the matrix

SEM images showing tempered cell colonies and coarse martensite

FIGURE 6. Carbides along grain boundaries

Heat treatment resulted in a microstructure that consists of a tempered martensite matrix with undissolved carbides dispersed. The microstructure of AISI 420 stainless steel after quenching and tempering is usually characterized by the presence of carbides, tempered martensite and eventually retained austenite, although martensite can persist in tempering temperature. Depending on the austenitizing temperature,  $\delta$ -ferrite may also be present. Large carbides are associated with  $M7C3$ , whereas small carbides are associated with  $M23C6$ . The failure of both the components was concluded to be due to wrong tempering treatment in the temperature range of 450–600 °C that cause grain boundaries to become susceptible to embrittlement. Microstructural condition
