Review Paper on Seismic Analysis of RCC Structure with Change in Vertical Irregularities Floor Wise

¹Gokulesh C. Chopde, ²Dr. Abhinandan R. Gupta

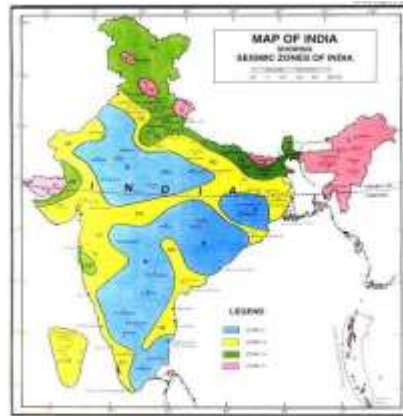
Fig. 4.1 Seismic Zoning map of India

The Indian subcontinent has a history of devastating earthquakes. The major reason for the high frequency and an intensity of the earthquakes is that the Indian plate is driving into Asia at a rate of approximately 47 mm/year. Geographical statistics of India show that almost 54% of the land are vulnerable to earthquakes. A World Bank and United Nations report shows estimates that around 200 million city dwellers in India will be exposed to storms and earthquakes by 2050. The latest version has of a seismic zoning map of India given in the earthquake resistant design code of India [IS 1893 (Part 1) 2002] assigning four levels of seismicity for India in terms of zone factors. In other words, the earthquake zoning map of India divides India into 4 seismic zones (Zone 2, 3, 4 and 5) unlike its previous version, which consisted of five or six zones for the country. According to the present zoning map, Zone 5 expects the highest level of seismicity whereas Zone 2 is associated with the lowest level of seismicity.

Zone 5 covers the areas with the highest risks zone that suffer earthquakes of an intensity MSK IX or greater. The IS code assigning a zone factor of 0.36 for Zone 5. Structural designers use this factor for an earthquake a resistant design of structures in Zone 5. The zone factor of 0.36 is indicative of effective (zero period) a level earthquake in this zone. It is referred to as the Very High Damage Risk Zone. The region of

This zone is called the High Damage Risk Zone and covers areas liable to MSK VIII. The IS code assigning a zone factor of 0.24 for Zone 4 Jammu and Kashmir, Himachal Pradesh, Uttarakhand, Sikkim, the parts of Indo-Gangetic plains (North Punjab, Chandigarh, Western Uttar Pradesh, Terai, North Bengal, Sundarbans) and the capital of the country Delhi falls in Zone 4. In Maharashtra, the Patan area (Koyanagar) is also in a zone no-4. In Bihar the northern part of the state like Raxaul, Near the border of India and Nepal, is also in a zone no-4.

This zone is classified as Moderate Damage Risk Zone which is liable to MSK VII. and also 7.8 The IS code assigns zone factor of 0.16 for Zone 3.

This region is liable to MSK VI or less and is classified as the Low Damage Risk Zone. The IS code assigns zone factor of 0.10 (maximum horizontal acceleration that can be experienced by a structure in this zone is 10% of gravitational acceleration) for Zone 2.

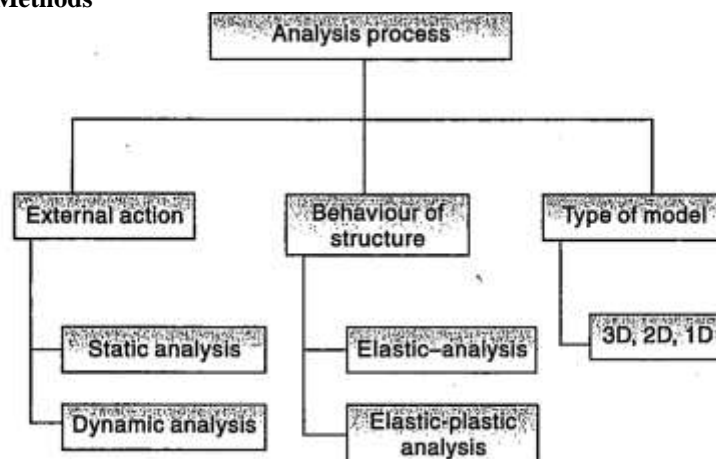
Fig. 4.4 Methods of Analysis

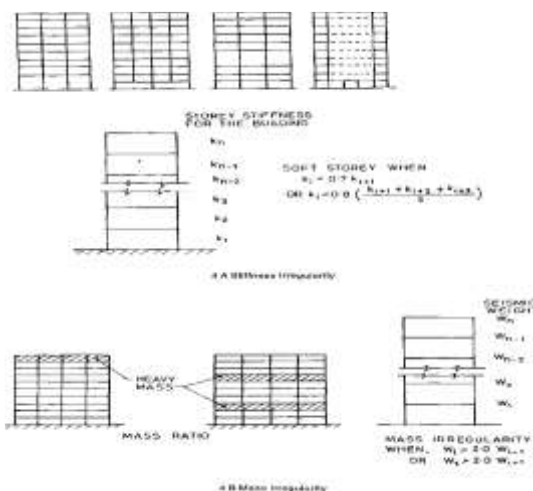
Fig.4.6 Vertical Irregularities

Fig. 4.6.1 Vertical Irregularities

Stiffness Irregularity —Soft Storey- A soft storey is one in which the lateral stiffness is less than 70 percent of that in the storey above or less than 80 percent of the average lateral stiffness of the three storeys above.

Stiffness Irregularity —Extreme Soft Storey -An extreme soft storey is one in which the lateral stiffness is less than 60 percent of that in the storey above or less than 70 percent of the average stiffness of the three storeys above. For an example, buildings on STILTS will fall under this category.

Mass Irregularity-Mass irregularity shall be considered to exist where the seismic weight of any storey is more than 200 percent of that of its adjacent storeys. The irregularity will need not be considered in a case of roofs.

Vertical Geometric Irregularity-Vertical a geometric irregularity shall be considered to exist where the horizontal dimension is of the lateral force is resisting a system in any storey is more than 150 percent of that in its adjacent storey.

In-Plane Discontinuity in Vertical Elements Resisting Lateral Force-A in-plane offset of the lateral force resisting elements greater than the length of those elements.

Discontinuity in Capacity — Weak Storey-A weak storey is one in which the storey lateral strength is less than 80 percent of that in the storey above, the storey lateral strength is the total strength of all seismic force resisting elements sharing the storey shear in the considered a direction.
