Geosynthetic Concrete Performance Analysis

Pooja M. Tayade¹, Om D. Rajput², Prashik K. Ingle³, Kunal P. Naik⁴, Mahendra D. More⁵, Prof. Santosh P. Bhise⁶

^{1,2,3,4,5} Students, Civil Engineering, Padm. Dr. V. B. Kolte College of Engineering, Malkapur, Maharashtra, India

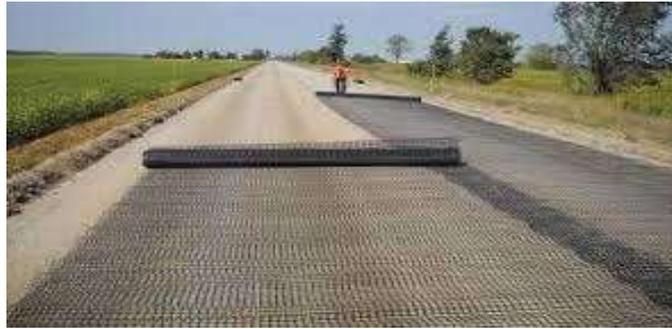
Fig. 1 Geosynthetics

Geosynthetics are here defined as fabrics, grids, composites, or membranes. Geo pertains to putting the material on or in the ground or earth (e.g., in a pavement) while synthetic refers to a man-made material. The geo prefix can also be applied to fabric, grid, composite, or membrane. Grids and composites are second-generation materials created for certain applications by certain manufacturers. Fabrics or geotextiles can be woven or nonwoven and are usually made up of thermoplastics like polypropylene or polyester but can also include nylon,

Filaments in nonwoven fabrics are generally mechanically bonded (needle-punched) or adhesively bonded (spun-bonded, heat or chemicals). Paving fabrics generally range from 4 to 6 ounces/yd² in weight. Technically, grids and composites are not geotextiles. Grids (geonets or mesh) can be woven from glass fibers or polymeric (polypropylene or polyester) filaments, or they can be cut or pressed from plastic sheets and post tensioned afterward to achieve maximum strength and modulus.

Grids usually have rectangular openings ranging from ¼ inch to 2 inches wide. A grid can be coated with a thin membrane laminated to it that helps with construction (i.e., bond to the asphalt tack coat) but melts and vanishes upon application of the hot HMA overlay. Furthermore, some grids have thin, permanent fiber strands partially occupying the apertures which bond the grid to the tack coat without creating a waterproof seal.

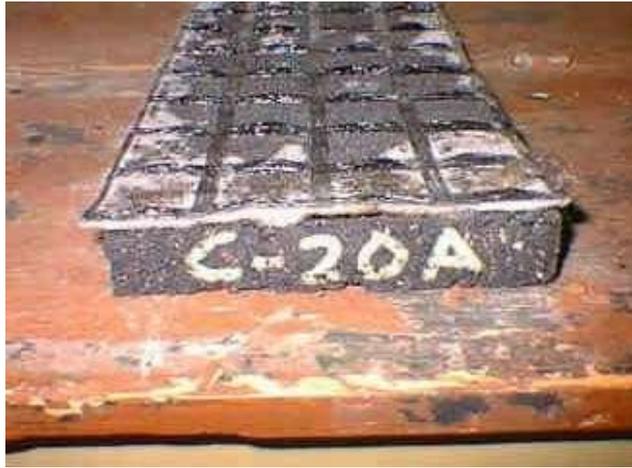
Fig -2: Uneven Coverage Using MS-1 Emulsified Asphalt Applied to Sample Beam C-20A with the HaTelit C40/17 Composite Product.

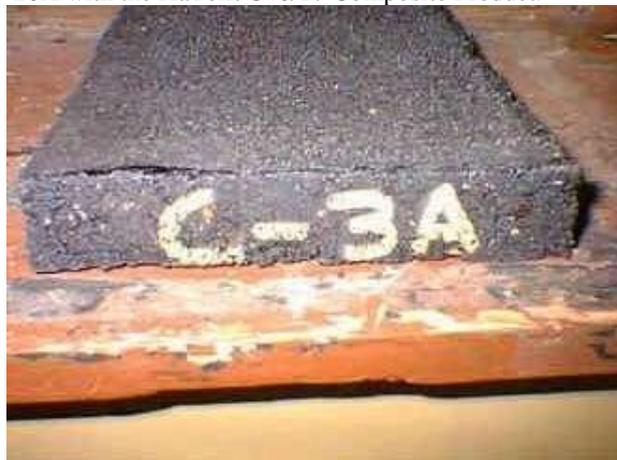
Fig -3: Lack of Complete Adhesion Using MS-1 Emulsified Asphalt Applied To Sample Beam C-3A with the Pav-Dry 381 Fabric.
